“Fastener Troubles, Causes & Solutions” Series

Failure of Roller Coaster Shaft: A Single Failed Thread Brought a Theme Park to a Complete Shutdown

by Toshimichi Fukuoka

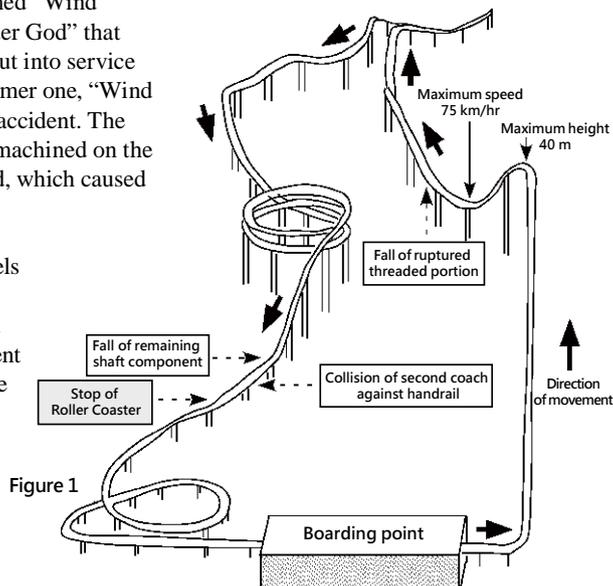
Figure 1 shows the roller coaster course where the accident took place. It had a maximum height of 40 meters, and a drastic spiral at the middle of the course. Top speed was 75 kilometers per hour. The coaster was highly popular especially among the youth, as an attraction that provides high speed and thrills. This course was run by two roller coaster trains named “Wind God” and “Thunder God” that were alternately put into service condition. The former one, “Wind God”, caused the accident. The threaded portion machined on the shaft end ruptured, which caused the falling off of the module that connects the wheels and car body. Finally, it resulted in a painful accident of the death of one passenger.

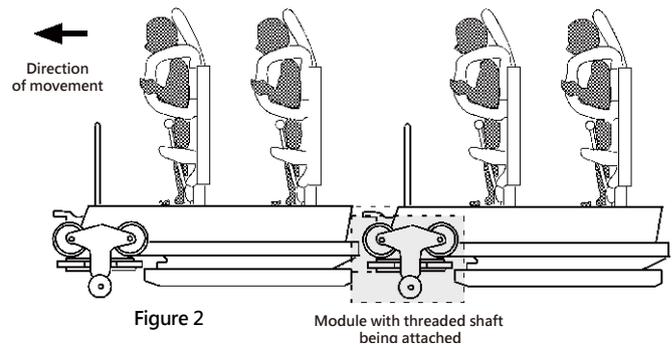
Figure 2 shows the state of the passengers boarding the roller coaster train. Since the passengers are boarding while standing, they can feel a strong physical sense of force owing to acceleration and deceleration. The lower part of Figure 2 represents the module. Figure 3 is the side view of the module, which is composed of 5 wheels gripping the rail. The center part of the figure is the ruptured shaft. Figure 4 shows the detailed structure of the module. The ruptured shaft had been designed to attach the module to the car body through the threads machined onto the shaft ends. Although the threads were machined on both the shaft ends, what ruptured was the inner one.

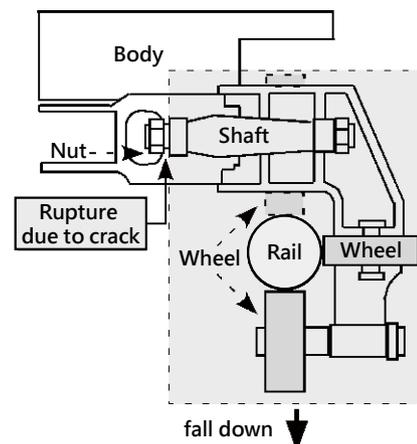
Please take a look at Figure 4 again. The portion where rupture occurred is located inside the car body, and has a shape that is difficult for visual inspection. On the other hand, it is clear that if the car body bears the load in the horizontal direction of the Figure, all the loads exert on the ruptured threaded portion. From this standpoint, it can be said that the difficulty in visual inspection indicates a problem in the design process, regardless of a dangerous portion being involved. At the time of the accident, the responsible engineer of the amusement facility manufacturer said that the fatigue failure was unexpected. Judging from this, we can make a conjecture that the responsible inspector did conduct only a simple check of the ruptured portion. If the shape of this module is necessary from the strength design point of view, the module should have been disassembled and checked regularly, even if it demands some cost.

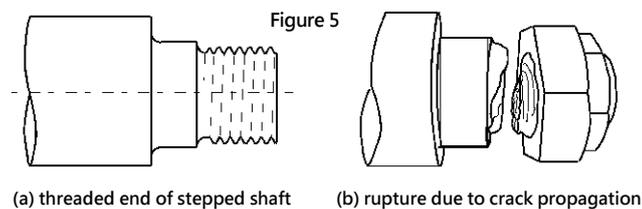
An investigation on the accident determined that the cause of the shaft rupture was the fatigue failure due to the repeated loads exerting on the threaded portion. Figures 5 (a), (b) respectively show the shapes of the thread portion on the shaft ends before and after the rupture. This shape of the ruptured portion is similar to the case of being subjected to “axial repeated tensile load” in standard thread fatigue tests. The picture indicates that the loads exerting in the axial direction of the shaft have a large influence. From the above considerations, it is presumed that the rupture is caused not only by the bending load exerting on the car body, but also by the tensile load due to centrifugal force. Although detailed analyses are required to explain how the load exerts on the running shaft, it is considered that the spiral portion placed in the latter part of the roller coaster course would have exerted quite an amount of axial load.

Another thing is the problem with shaft shape. As shown in Figure 5(a), the threaded portion has a stepped shape in two stages, so that its diameter is fairly smaller than that of the car shaft itself. Furthermore, this portion with thinner diameter is very short for the total length of the shaft. Employing such a shape, the “ability to absorb strain energy” becomes extremely low when subjected to axial load. I will explain this phenomenon by means of simple solid mechanics.

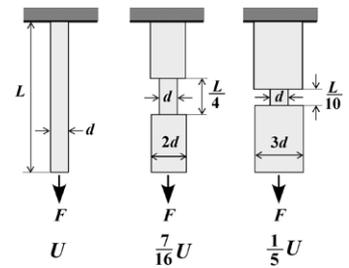
Figure 6 shows how much strain energy is accumulated and degraded in partly stepped bars, assuming that the strain energy for a straight round bar, with length L and diameter d , under tension being U . In case of the bar on the far right in Figure 6, for instance, it can only absorb one fifth of the strain energy of a perfectly straight round bar.

The shaft of the roller coaster is similar in shape to the ones at the center and the far right of the Figure, in which the shafts have partly thinner portions. That is, in the case of the shaft of this type, the ability of the whole bar for accumulating the strain energy decreases, because the stress of the thicker portions is low and the shaft scarcely elongates even under axial load.

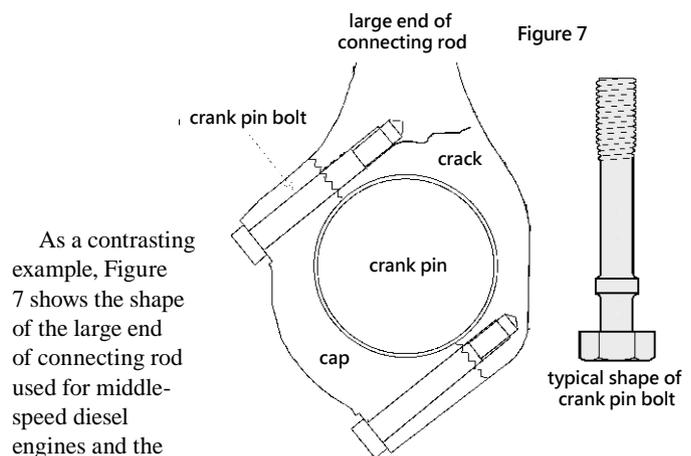
As a contrasting example, Figure 7 shows the shape of the large end of connecting rod used for middle-speed diesel engines and the crank pin bolt used for fastening. Because the crank pin bolt is subjected to a large amount of bending load, the bolt is wholly machined thinner for easy bending. As a result, it is possible to suppress the amount of stress variation caused by the external force, namely the “stress amplitude”, which is the major cause for fatigue failure. From the above considerations, we can conclude that the shape of the threaded portion of the roller coaster train shaft, which caused the tragic accident, is not preferable from the standpoint of solid mechanics.
