Heavy Price of Poor Maintenance and Sloppiness

Copyright owned by Fastener World / Article by Jozef Dominik

“Poorly maintained equipment and sloppiness can lead to serious accidents.”

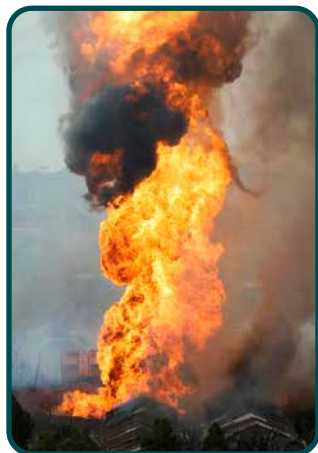
▲ Fig. 01. Gas explosion (Wiki)

We can encounter this old truth in preamble almost every day in various areas of economic activity. The latest dramatic explosion in a Malaysian (April 1, 2025) gas pipeline (**Fig. 01**) would be a reminder. Leaks in the gas pipeline sends fire spreading to villages.

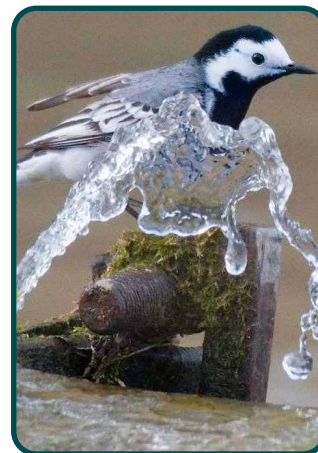
▲ Fig. 02. Bird on a leaky pipe

How much more pleasant is the sight of a bird flapping its wings on a leaky water pipe (**Fig. 02**). Unfortunately, emotional feelings play no role here. In both cases, the cause was a leak in the pipe; in the first case a gas pipe, in the second, a water pipe.

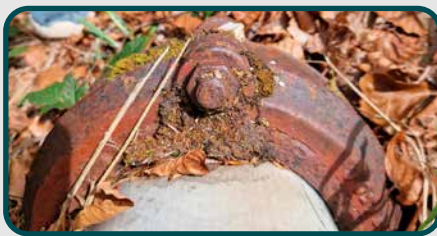
▼ Fig. 07 Rusty flange

- Corrosion (**Fig. 07 - 09**)
- Loosening of bolted joints
- Damage to the seal on flanges

Corrosion itself is also a specific problem for pipelines. In contrast to the common types of corrosion of bolted joints, there is external or atmospheric corrosion and internal corrosion as a result of the effect of aggressive components contained in the transported medium. It is not uncommon for it to be a combination of both. Welding a steel sheet (**Fig. 09**) is only effective for a short time. If the area around the weld is not treated properly, it corrodes very quickly.

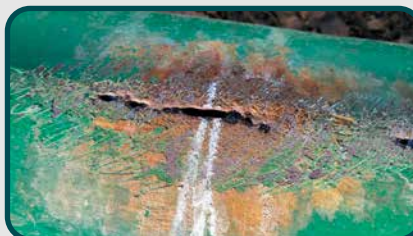
▼ Fig. 08 Crack in a pipe

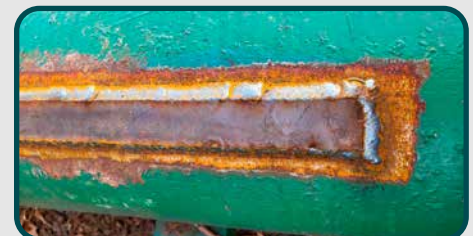
▼ Fig. 09 Welding

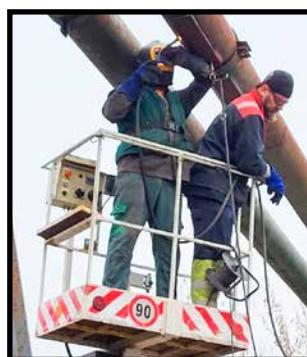
▼ Fig. 10 Welding at height

It is also important to take into account the fact that pipe repairs often take place in hard-to-reach places (**Fig. 10**). Sometimes it is a difficult and expensive matter. Not only pipeline repair at height is at least twice as expensive, it is also more difficult than on the ground. The same applies to routine checks of the condition of bolted joints in hard-to-reach places.
