# Hydrogen Embrittlement

by Laurence Claus

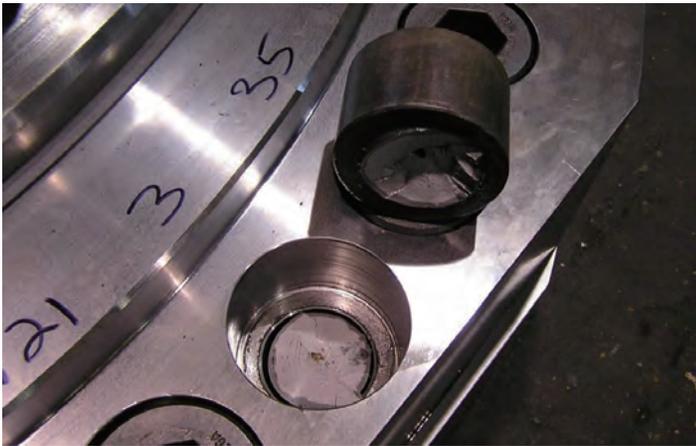
*A Socket Head Cap Screw that has Failed by Hydrogen Embrittlement (used with permission of SV Brahimi)*
